Manhole Inspection Summary

Manhole # S15EE1028MH

Insp Date: **3/6/07 9:02 AM**

Location Address: **2427 KEYWORTH AVE**

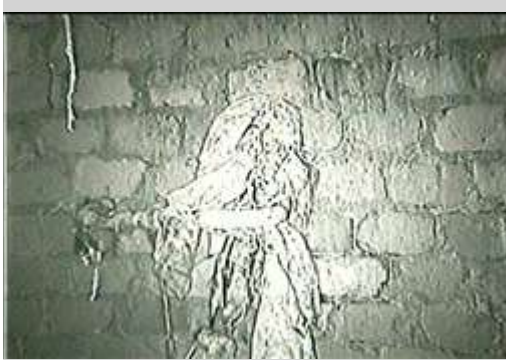
Evidence Of surcharge

Surcharge ☒ **Evidence Of Surcharge** Depth: **3.5** (ft.) ☐ Active Surcharge Present

Evidence of surcharge - Bench debris.

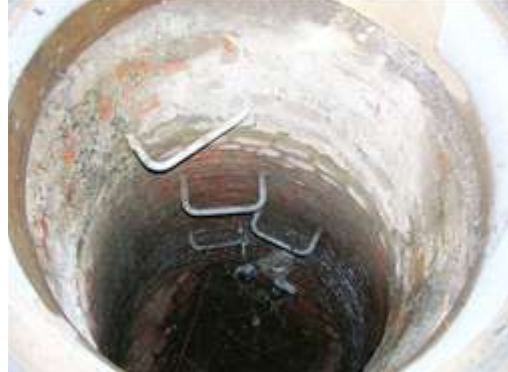
Defect

Frame leaks. Adjustment deterioration and infiltration. Corbel and Barrel infiltration

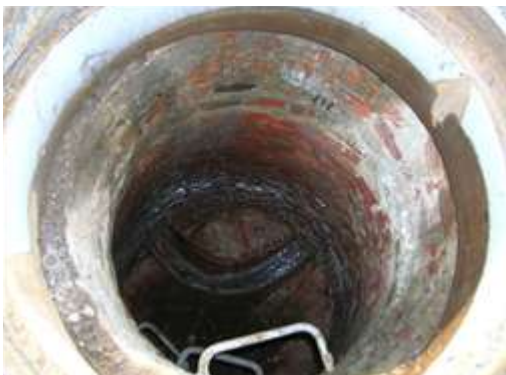
Defect

Frame leaks. Adjustment, Corbel and Barrel infiltration. - other side.

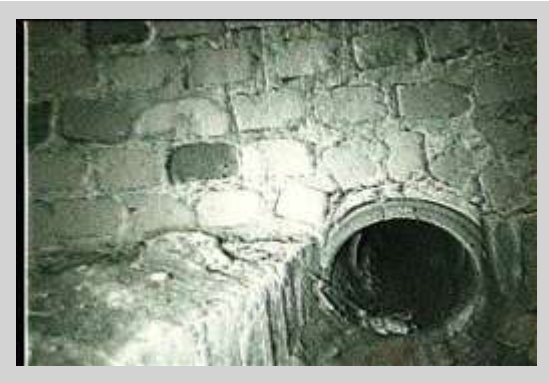
8 in. Circular Gravity Sewer Pipe Out @ 12 O'Clock

Barrel deterioration and infiltration.

Infiltration: **Evidence** Pipe Seal Cond: **Cracked**

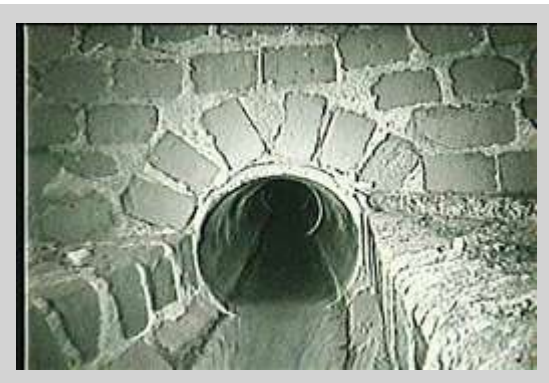
8 in. Circular Gravity Sewer Pipe In @ 3 O'Clock

Channel deterioration.

Infiltration: **Evidence** Pipe Seal Cond: **Unknown**
